Confidential Inspection Report

LOCATED AT: 90 Seacrest Lane Warwick, Rhode Island

INSPECTED ON: Tuesday, April 25, 2017

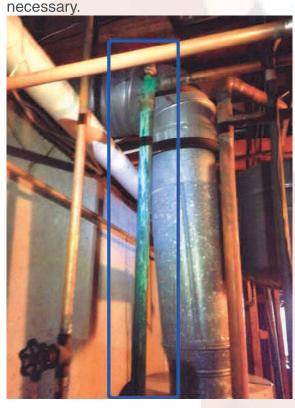
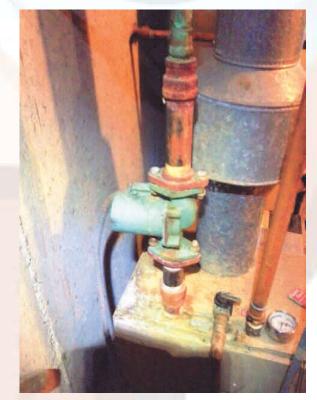
13: - The piping for the heating system is displaying minor signs of external corrosion. We recommend these sections of piping be monitored for further deterioration and replaced when
